CLARENCE J. BROWN RESERVOIR
GREATER MIAMI RIVER BASIN
OHIO

EMBANKMENT CRITERIA AND
PERFORMANCE REPORT

PREPARED BY
U.S. ARMY ENGINEER DISTRICT, LOUISVILLE
CORPS OF ENGINEERS

SEPTEMBER 1982

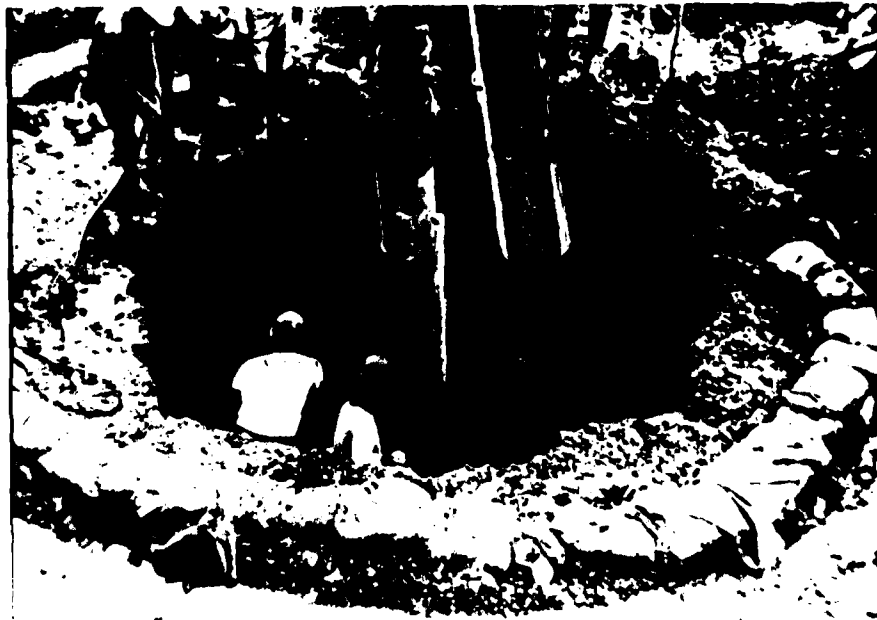
(4) Placing 8' x 8' x 5' concrete plug around 12" pipe drain into artesian well at E station 24+10.
